NDI No. PA 01069
PENN DER No. 10-26

TREESDALE FARM DAM

PHASE I INSPECTION REPORT
NATIONAL DAM INSPECTION PROGRAM

MARCH 1981

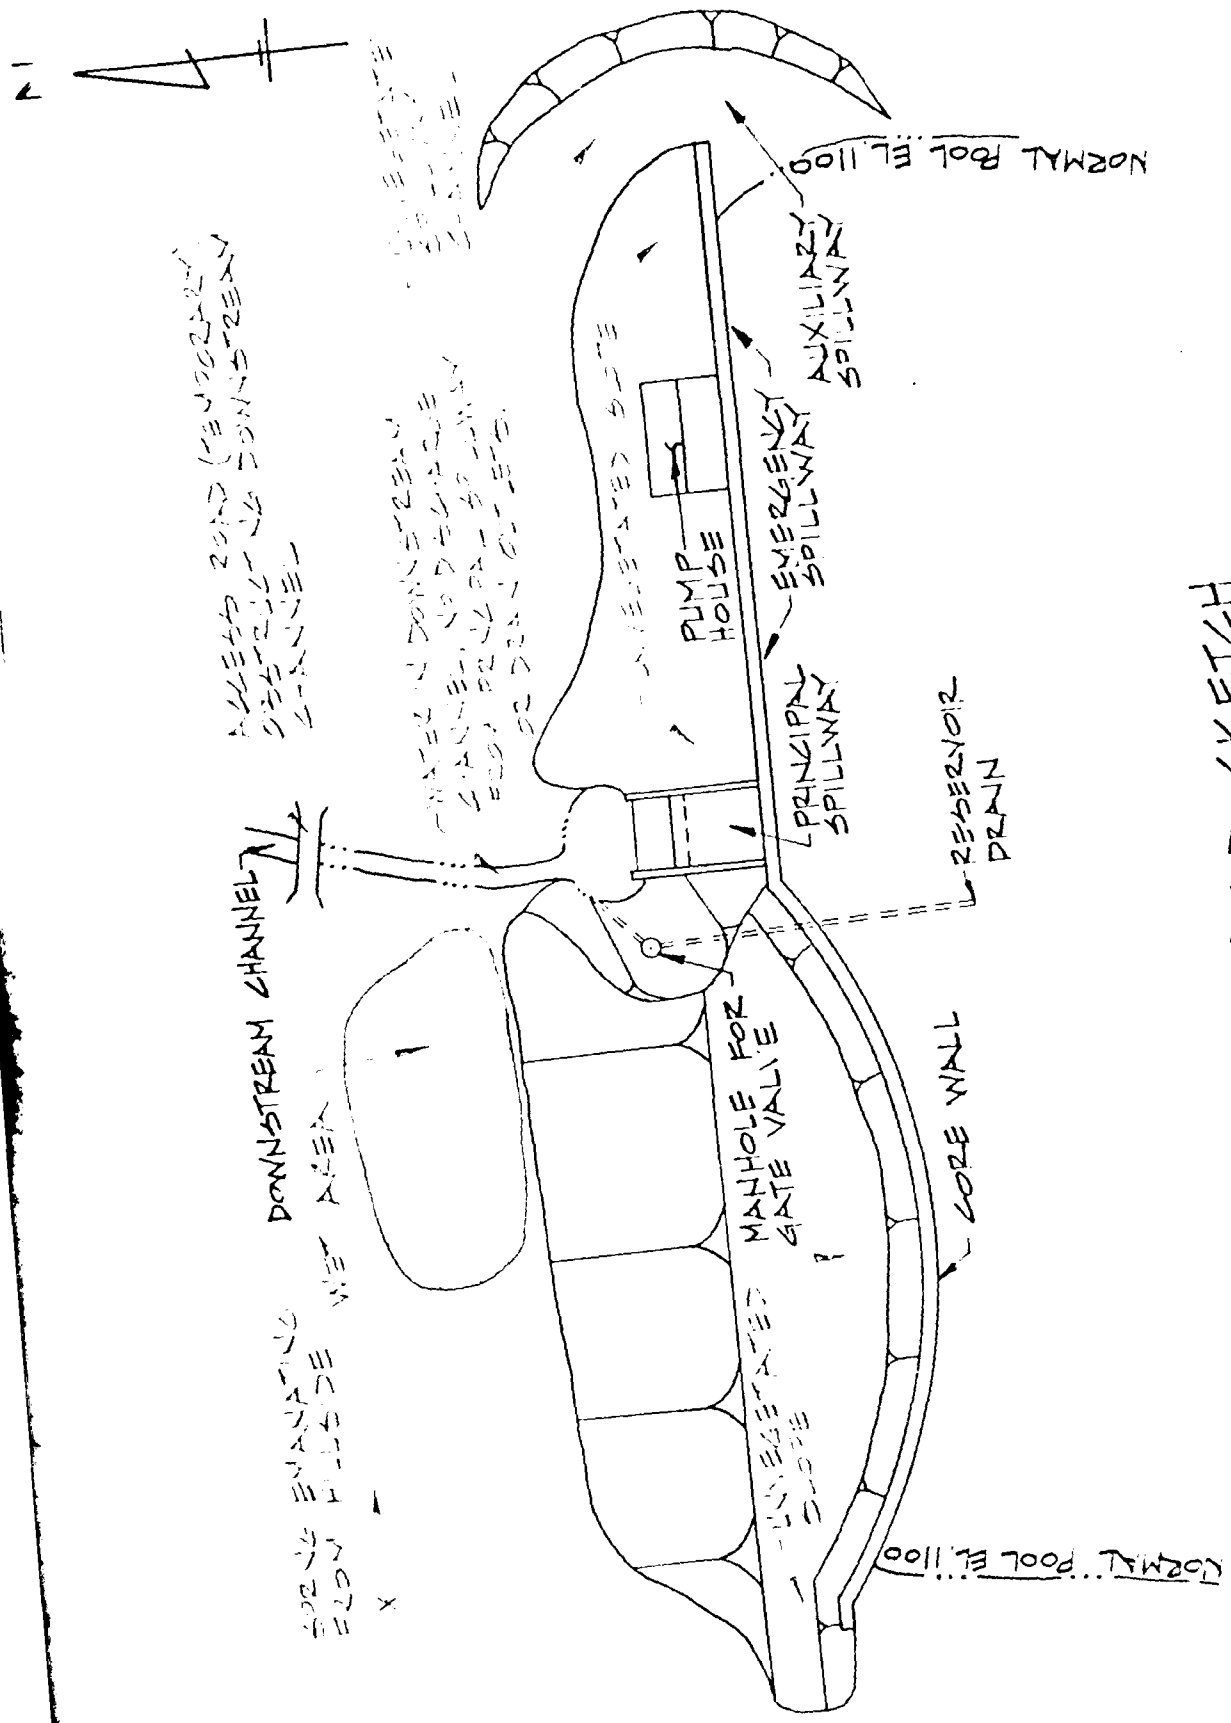
FIELD SKETCH TREESDALE FARM DAM

3. Wet Zones: A wet zone with ponded water was observed below the downstream toe and to the left of the downstream channel. The wet zone is situated in a low lying area and is believed subject to surface runoff from rainfall and springs in the left abutment. A spring emanating from the left abutment was observed and is shown on the field sketch.

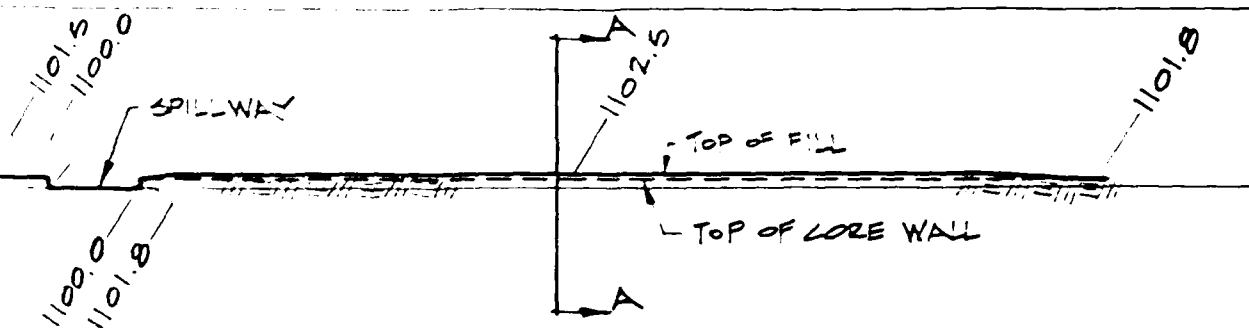
DAM CREST PROFILE - LOOKING UPSTREAM

The crest of the fill on the downstream slope left of the principal spillway varies from El. 1101.8 to El. 1102.5 rather than El. 1103.5 as proposed (Plate No. 8). Until construction is completed, the dam will have less freeboard than planned. This may or may not be a deficiency, depending upon the results of the hydrologic/hydraulic analysis.
